RE: Structural Assessment Report
Sumner County Football Stadium Bleachers

Structural Assessment Report
Sumner County Football Stadium Bleachers

As requested, Kaatz, Binkley, Jones and Morris Architects, Inc. (KBJM) performed a structural condition assessment of all eight Sumner County High School football stadium bleachers. The structural assessments were performed by Sandra Olandt, PE on August 16, 2023, and August 17, 2023.

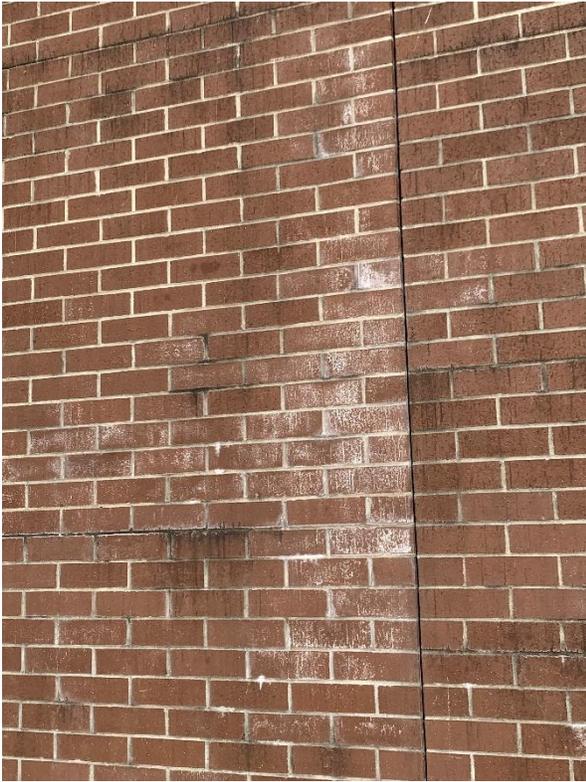
On approach to the structure, the bleachers look well maintained and attractive. The guard rail is in good condition and appears to be relatively new. Efflorescence is present in the exterior brick veneer on the side walls, but no significant cracking exists. The intermediate back walls have been painted and there are signs of spalling masonry. Upon entering the underside of the bleachers, the supporting masonry walls were found to be in very poor condition. The masonry is saturated with a large amount of moss growing on the walls. Multiple cracks run vertically in the walls and portions of masonry block are missing. The face of the masonry is disintegrating in multiple locations. The masonry lintels above the openings between bays have lost most of the face shell of the masonry and are left with exposed grout in the bond beam. At one opening, even the grout has deteriorated to expose the lintel reinforcing which is badly rusted. Within the built-out interiors below the bleachers, the ceilings have collapsed due to severe water intrusion. The concrete planks appear to be in good condition as viewed from both above and below. However, the gaps between planks at the point of bearing have no joint sealant, allowing water to infiltrate the masonry wall below. Damage to the structure is water related, the foundations appear to be stable with no settlement cracking in the masonry.

Efflorescence on brick veneer.

Based on the extremely poor condition of the masonry support walls, it is my professional opinion that the Home side bleachers are at the end of their life span and should no longer be used in their current condition. I recommend that either extensive repairs be made, including replacement of the load-bearing masonry walls, or the entire structure be demolished and replaced with a galvanized steel and aluminum structure. The information required to make a repair or replacement decision is beyond the scope of this report.

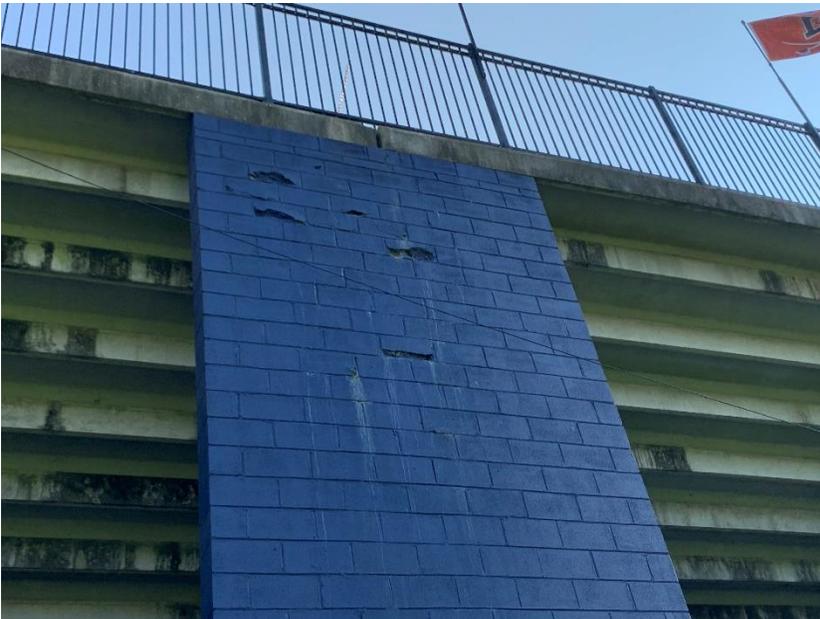
Spalling masonry along rear wall.

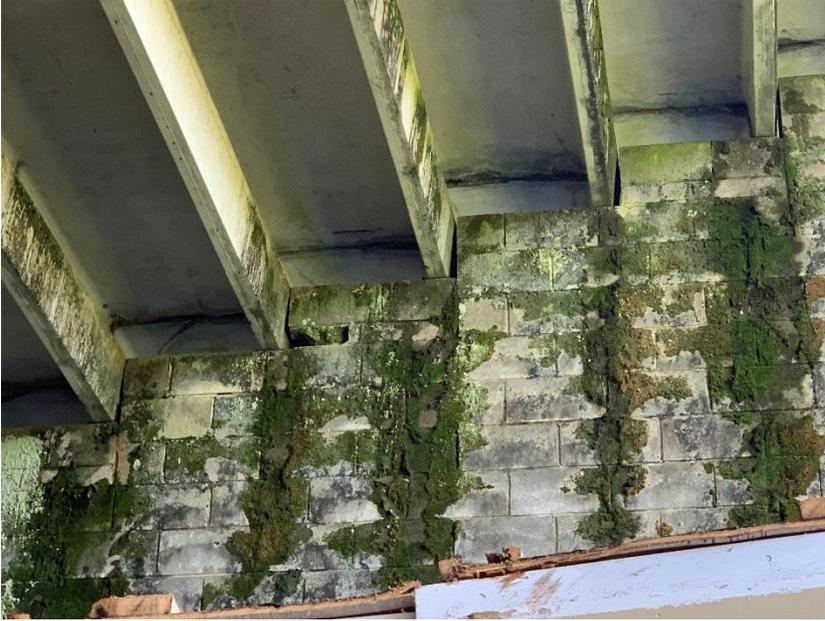
The original design of the stadium does not provide any redundancies in the structural system. The interior masonry walls support planks on both sides which then systematically support the next plank above until reaching the top. Failure of one structural element can lead to a progressive catastrophic collapse. The long-term presence of water within the masonry is evident from the moss growth on the structure. Water infiltration is one of the most damaging problems for masonry construction, particularly when partnered with the freeze-thaw cycles in the climate of Tennessee. The expanding water during a freeze will cause multiple cracks to form and eventually lead to spalling and deterioration of the face shell as seen in this structure. In addition, the water rusts the steel reinforcing reducing or eliminating any

strength and continuity that it initially provided. As the masonry continues to deteriorate, the overall integrity of the system is lost, and collapse is imminent.

Water infiltration, moss growth, cracking and loss of section in interior masonry wall.

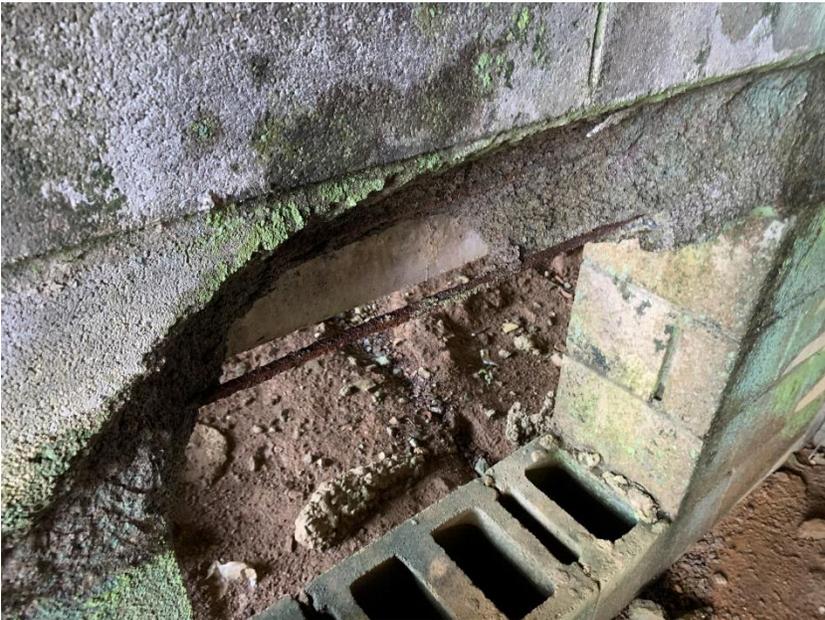
Loss of masonry and grout with exposed reinforcing in masonry lintel.

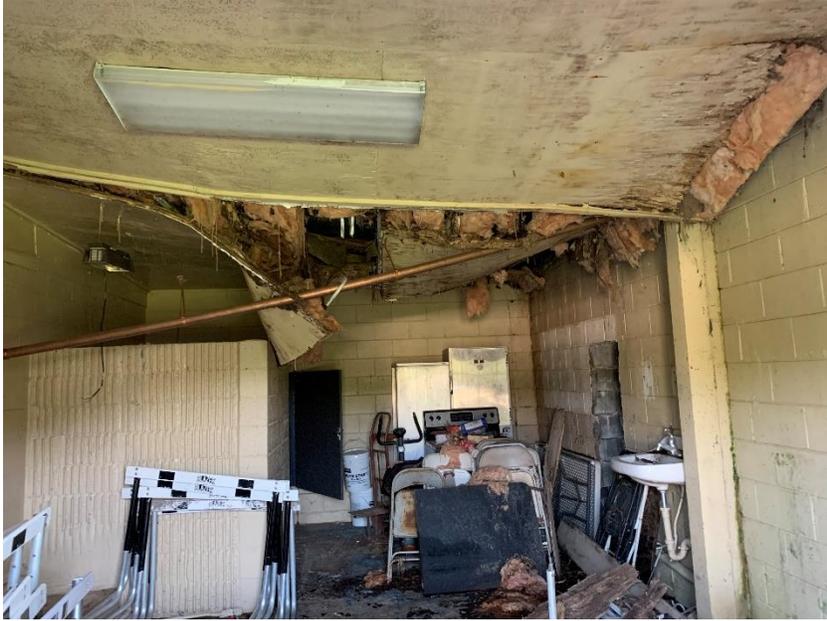
Water infiltration to built-out area beneath bleachers.

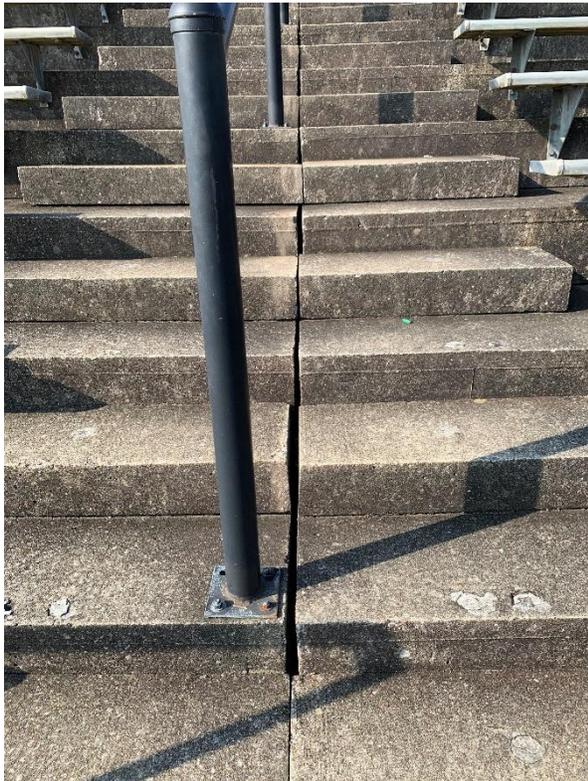
Absence of joint sealant between concrete planks.

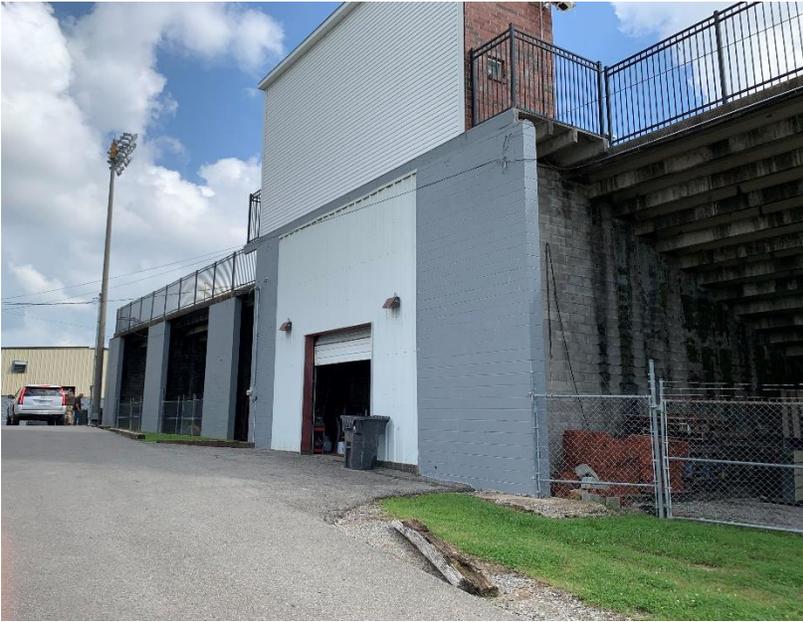
Back side of Home side bleachers.

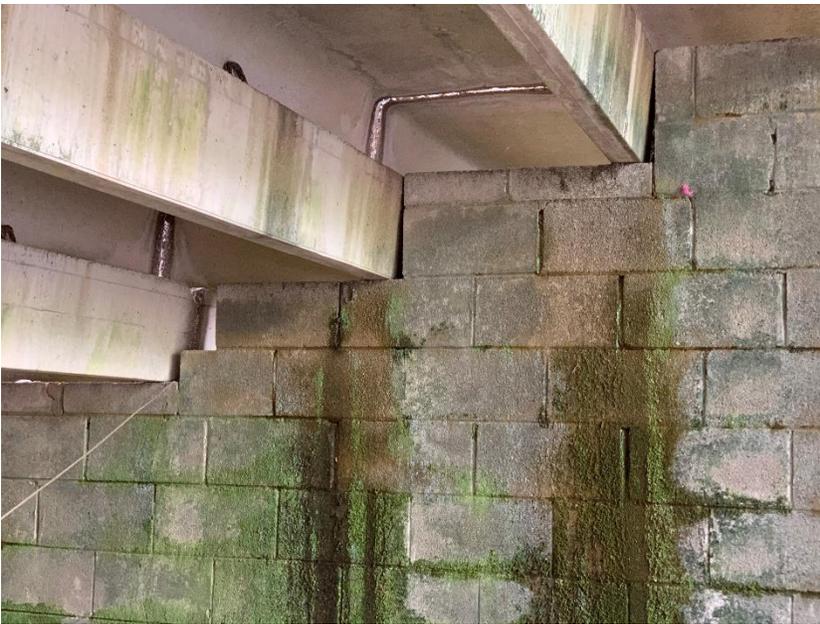
On approach to the structure, the bleachers look well maintained and attractive. The guard rail is in good condition and appears to be relatively new. The exterior brick veneer on the side walls is in good condition with no significant cracking. The intermediate back walls have been painted and are in good condition with only a few places with damaged masonry. Upon entering the underside of the bleachers, the supporting masonry walls were found to be in fair condition. Although the walls show some water saturation and moss growth, there is not significant cracking, and the surface face of the block is not as deteriorated as seen at Beech High School. The masonry lintels above the openings between bays are still intact. Within the built-out interiors below the bleachers, the insulation board ceilings and supporting steel members do not show signs of water infiltration. The concrete planks appear to be in fair condition as viewed from both above and below. Water staining is more evident indicating the planks may not have been coated with a concrete sealer. There is one plank on the left side section of bleachers that has been displaced by approximately 2", possibly when constructing the build-out below. The gaps between planks at the point of bearing have no joint sealant, allowing water to infiltrate the masonry wall below. Damage to the structure is water related, the foundations appear to be stable with no settlement cracking in the masonry.

Interior Home side masonry walls with water infiltration and moss growth.

- Masonry walls should be treated to remove the moss growth and prevent future growth.

Prior to the start of the 2024 spring track season, the Home side bleachers should be visually assessed for further damage from winter freeze before allowing use of the structure. I recommend that a plan be put in place to either provide extensive repairs to the Home side, including replacement of the load-bearing masonry walls, or that the entire structure be demolished and replaced with a galvanized steel and aluminum structure. The repair or replacement should take place as soon as feasible. The information required to make a repair or replacement decision is beyond the scope of this report. Until this decision is made and implemented, the existing structure should be inspected before each football season and track season to determine suitability for use.

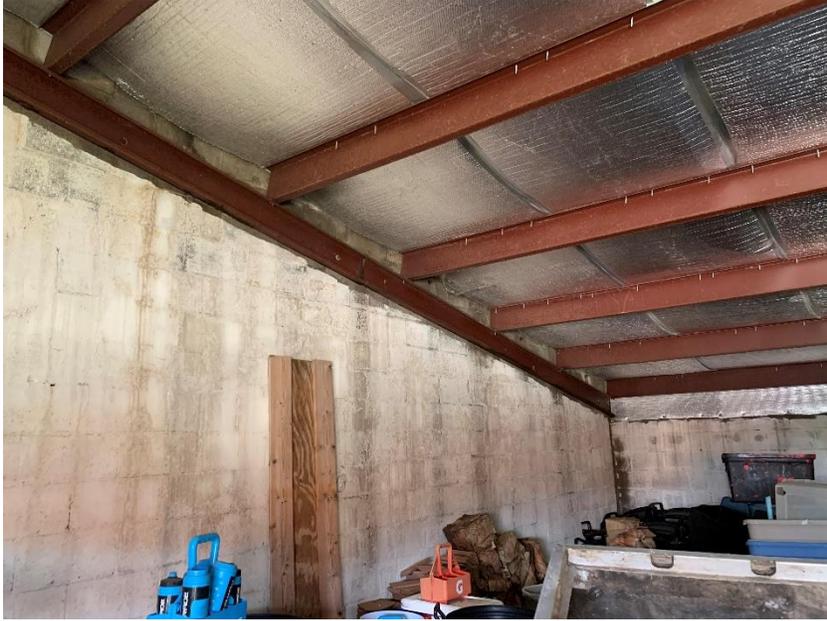
Interior masonry built-out space below Home side bleachers without water infiltration.

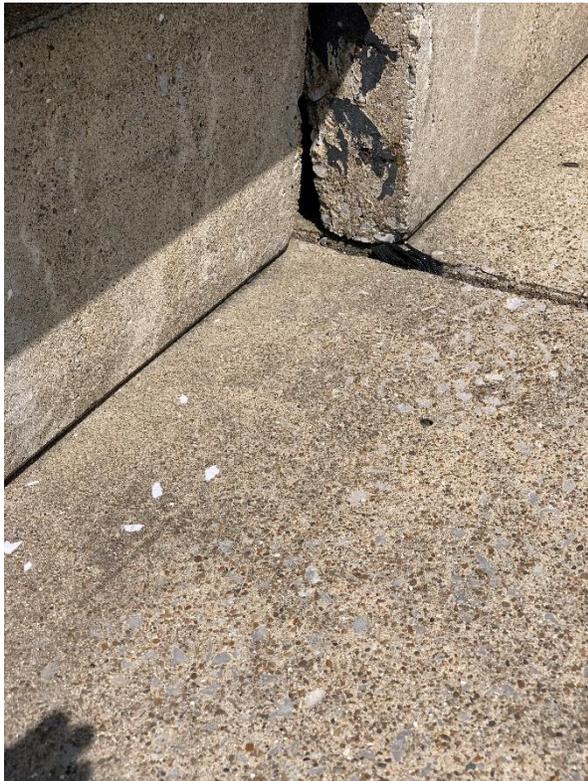
Single displaced concrete plank on left side section of Home side bleachers.

- Before and after each use, members of the maintenance staff familiar with the current condition of the structure should perform a visual assessment of the plank which is out of alignment. Changes to the alignment of this plank, and any other planks, should be reported to the Structural Engineer as soon as they are found.

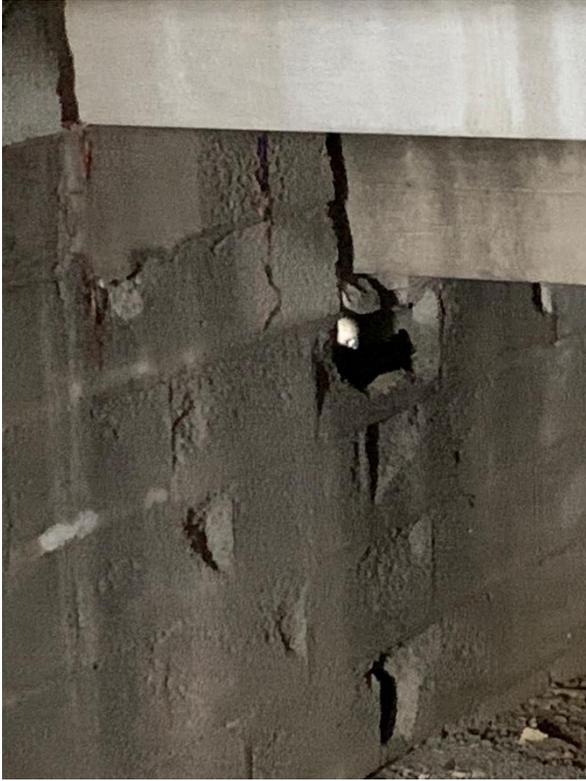
On approach to the structure, the bleachers look well maintained and attractive. The guard rail is in good condition and appears to be relatively new. The exterior brick veneer on the side walls is in good condition with no significant cracking. The back walls have been painted and are in fair condition with several areas of spalling masonry. Upon entering the underside of the bleachers, the supporting masonry walls were found to be in very poor condition. The walls show water saturation but no moss growth since these areas are entirely enclosed. There is significant loss of the surface face of the masonry with several areas suffering a complete loss of section leaving a hole through the wall. The concrete planks appear to be in fair condition as viewed from both above and below. Water staining is more evident indicating the planks may not have been coated with a concrete sealer. One bay has an interior support wall and repairs to a concrete plank indicating previous problems with the structure were repaired. The gaps between planks at the point of bearing have no joint sealant, allowing water to infiltrate the masonry wall below. Damage to the structure is water related, the foundations appear to be stable with no settlement cracking in the masonry.

The original design of the stadium does not provide any redundancies in the structural system. The interior masonry walls support planks on both sides which then systematically support the next plank above until reaching the top. Failure of one structural element can lead to a progressive catastrophic collapse. The long-term presence of water within the masonry is evident from the moss growth and the disintegrating masonry block. Water infiltration is one of the most damaging problems for masonry construction, particularly when partnered with the freeze-thaw cycles in the climate of Tennessee. The expanding water during a freeze will cause multiple cracks to form and eventually lead to spalling and deterioration of the face shell as seen in this structure. In addition, the water rusts the steel reinforcing reducing or eliminating any strength and continuity that it initially provided. As the masonry continues to deteriorate, the overall integrity of the system is lost, and collapse is imminent.

Extensive loss of section in Visitor side masonry wall.

Based on the extremely poor condition of the masonry support walls, it is my professional opinion that the Visitor side bleachers are at the end of their life span and should no longer be used in their current condition. It is my opinion that the Home side bleachers are nearing their functional life span but are still safe for use for the remainder of the 2023 football season. However, since appearances are not complete indicator of structural integrity, I recommend the follow provisions be in place for the remainder of the season:

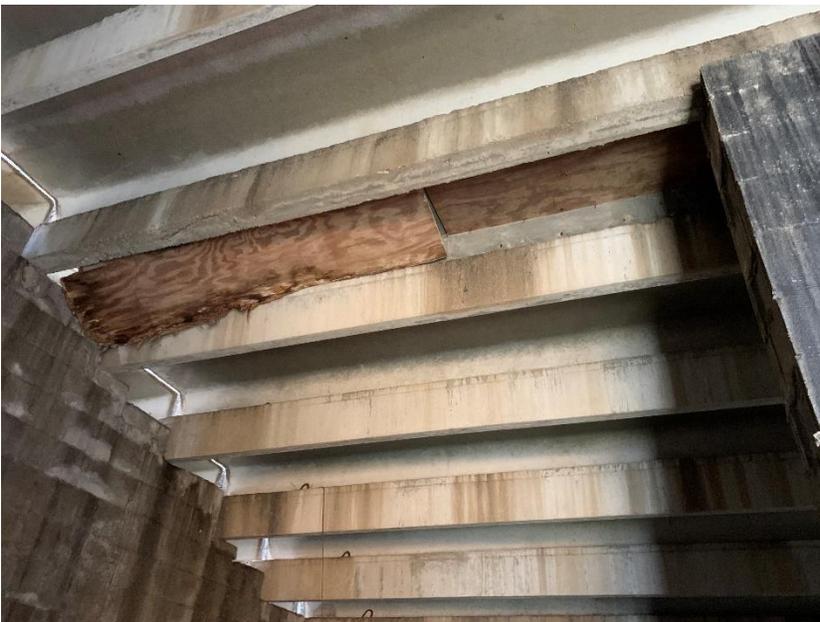
Previous repair to concrete plank and infill masonry wall providing intermediate support.

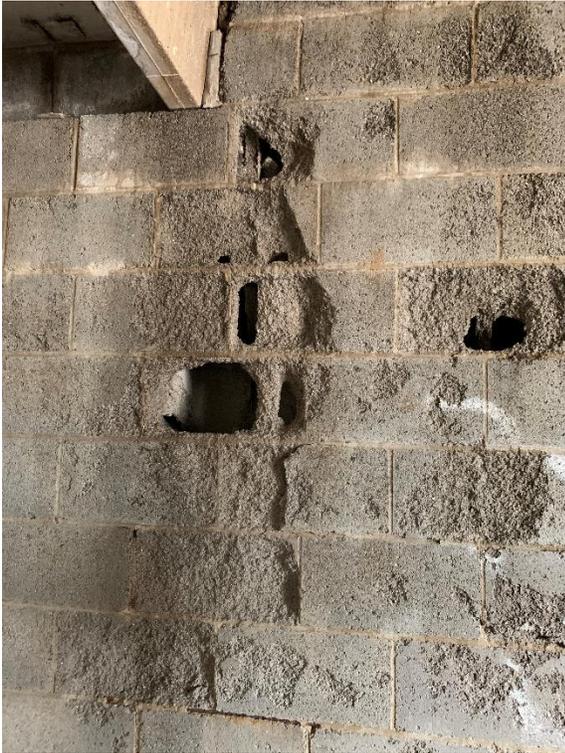
On approach to the structure, the outer bleachers look well maintained but the original sections are showing signs of age. Upon entering the underside of the original bleachers, the supporting masonry walls were originally found to be in good condition. It was then determined that new exterior side walls had been added to the interior, but the old side walls were left in place. Water saturation in the original walls was seeping through to the newer walls. The interior wall sections of the outer two bays had not been replaced and were in very poor condition. There was a significant loss of face section of the masonry blocks leaving holes through to the other side. The concrete plank above also showed significant signs of deterioration with exposed reinforcing on the underside of the plank in both the stem and the web areas. The front retaining wall was bowed and cracked along the length of the top bond beam indicating that the planks were pushing the wall forward. The gaps between planks at the point of bearing were previously filled with joint sealant, but much of it has deteriorated beyond usefulness allowing water to infiltrate the masonry wall below.

The original design of the Home side stadium does not provide any redundancies in the structural system. The interior masonry walls support planks on both sides which then systematically support the next plank above until reaching the top. Failure of one structural element can lead to a progressive catastrophic collapse. Long term water infiltration in the block is evident and is one of the most damaging problems

for masonry construction, particularly when partnered with the freeze-thaw cycles in the climate of Tennessee. The expanding water during a freeze will cause multiple cracks to form and eventually lead to spalling and deterioration of the face shell as seen in this structure. In addition, the water rusts any steel reinforcing that might be present, reducing or eliminating any strength and continuity that it initially provided. As the masonry continues to deteriorate, the overall integrity of the system is lost, and collapse is imminent.

Home side masonry wall with extensive loss of section.

Based on the extremely poor condition of the interior masonry support walls, it is my professional opinion that the original section of the Home side bleachers are at the end of their life span and should no longer be used in their current condition. I recommend that either extensive repairs be made, including replacement of all original load-bearing masonry walls, or entire structure be demolished and replaced with a galvanized steel and aluminum structure. The information required to make a repair or replacement decision is beyond the scope of this report.

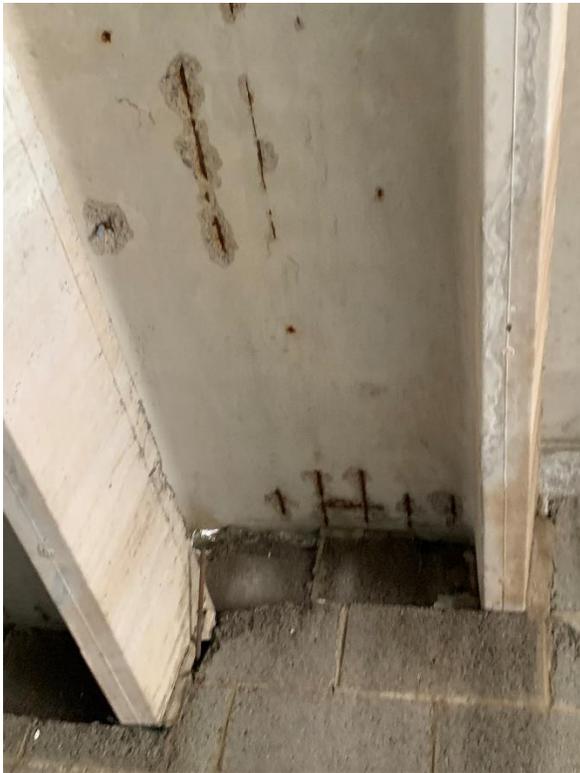
Underside of concrete plank with deterioration of the concrete and exposed steel reinforcing.

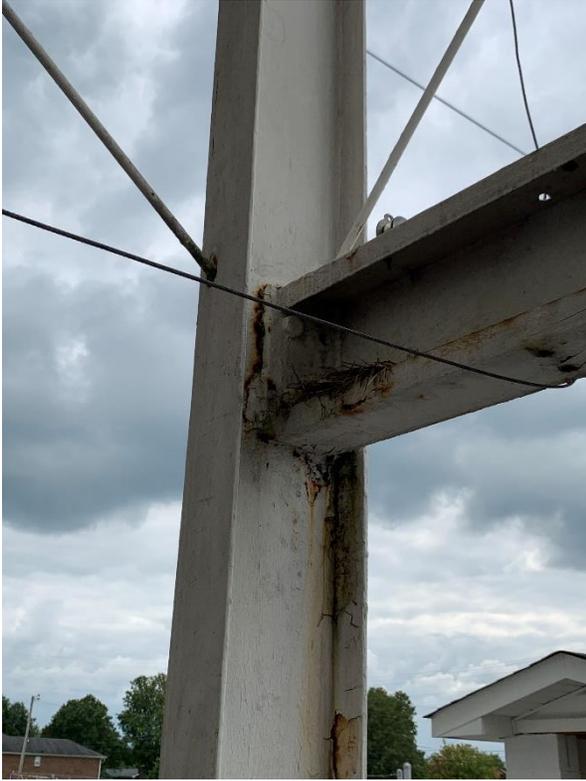
The newer sections flanking the original bleachers are in good condition. The steel structure supporting the press box is also in good condition except for some rusting at the exposed connections. The portable bleachers appeared in good condition but were beyond the scope of this assessment.

Rusting steel in the column support of the Home side press box.

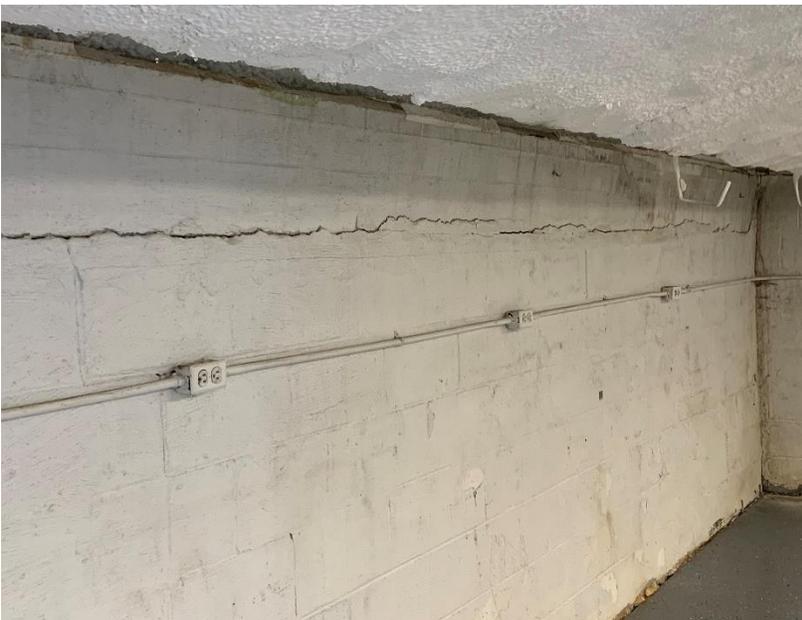
Cracking along the length of the top of the skirt wall along the front of the Home side bleachers.

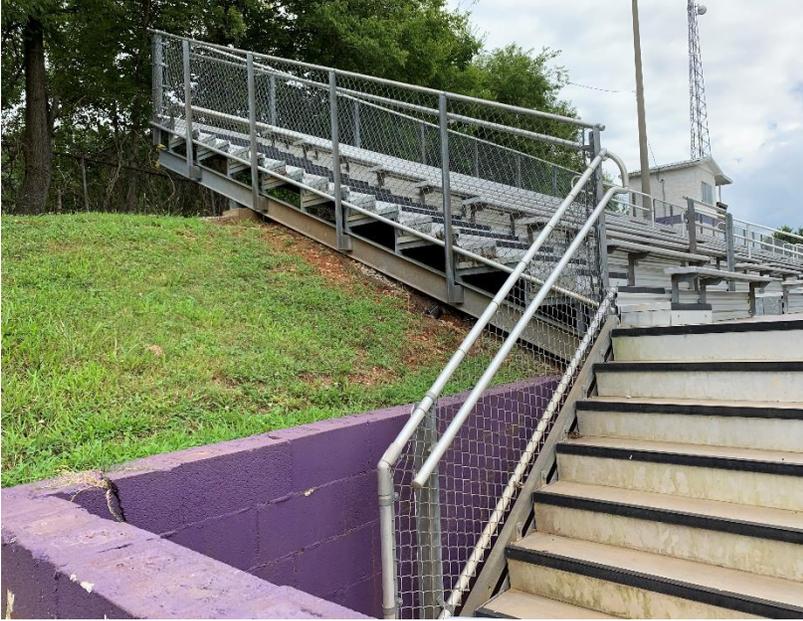
Most of the underside of the Visitor side bleachers is inaccessible. Viewed from the side and back of the bleachers and also from above, the structure appears to be in good condition. However, the short retaining wall along the walkway to the concession stand is starting to fail. There are significant cracks in the masonry and the face shell of the blocks is spalling in numerous locations.

Side view of Visitor side galvanized steel bleachers built into the hill.

The two newer sections of bleachers flanking the original sections on the Home side, as well as the Visitor side bleachers can continue to be used at this time. Safety inspections should be conducted on these bleachers on an annual basis in accordance with International Code Council Standards for Bleacher, Folding and Telescoping Seating, and Grandstands (ICC-300) and the manufacturer's written guidelines. These inspections can be made by a qualified individual familiar with the requirements and should be documented.

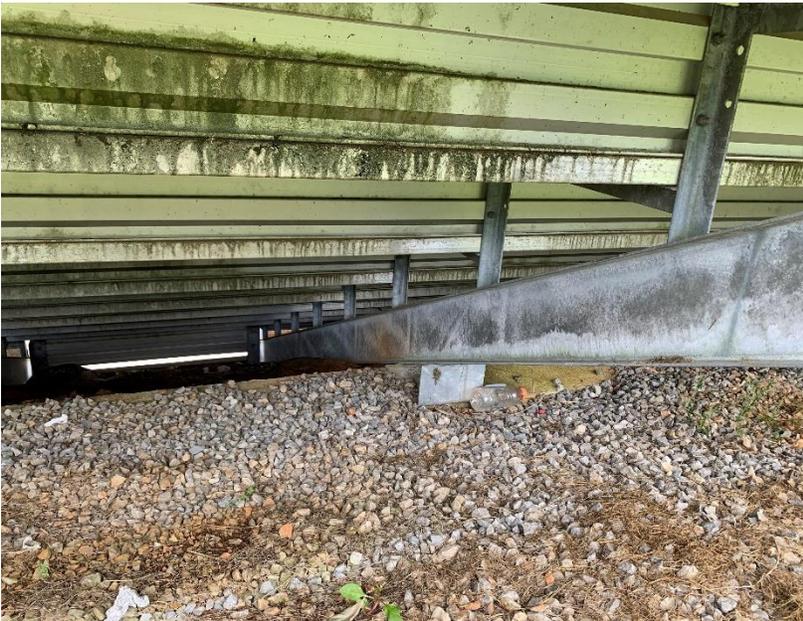
View of back side of Visitor side bleachers built into the hill.

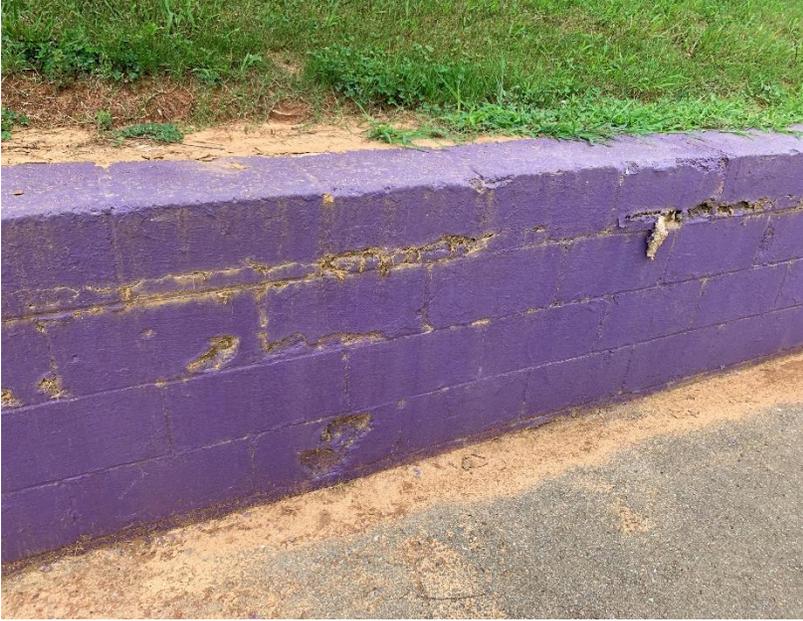
Deterioration of retaining wall along the Visitor side path to concessions.

The retaining wall on the Visitor side should continue to be monitored. As deterioration and deformation increase, this wall should be replaced.
